**ASTM C 1363-11 THERMAL PERFORMANCE
TEST REPORT**

SERIES/MODEL: Masonry Tie Thermal Evaluations (2x6 Steel Stud Wall)

TYPE: Masonry Wall Assembly

Report No: E8317.01-116-46

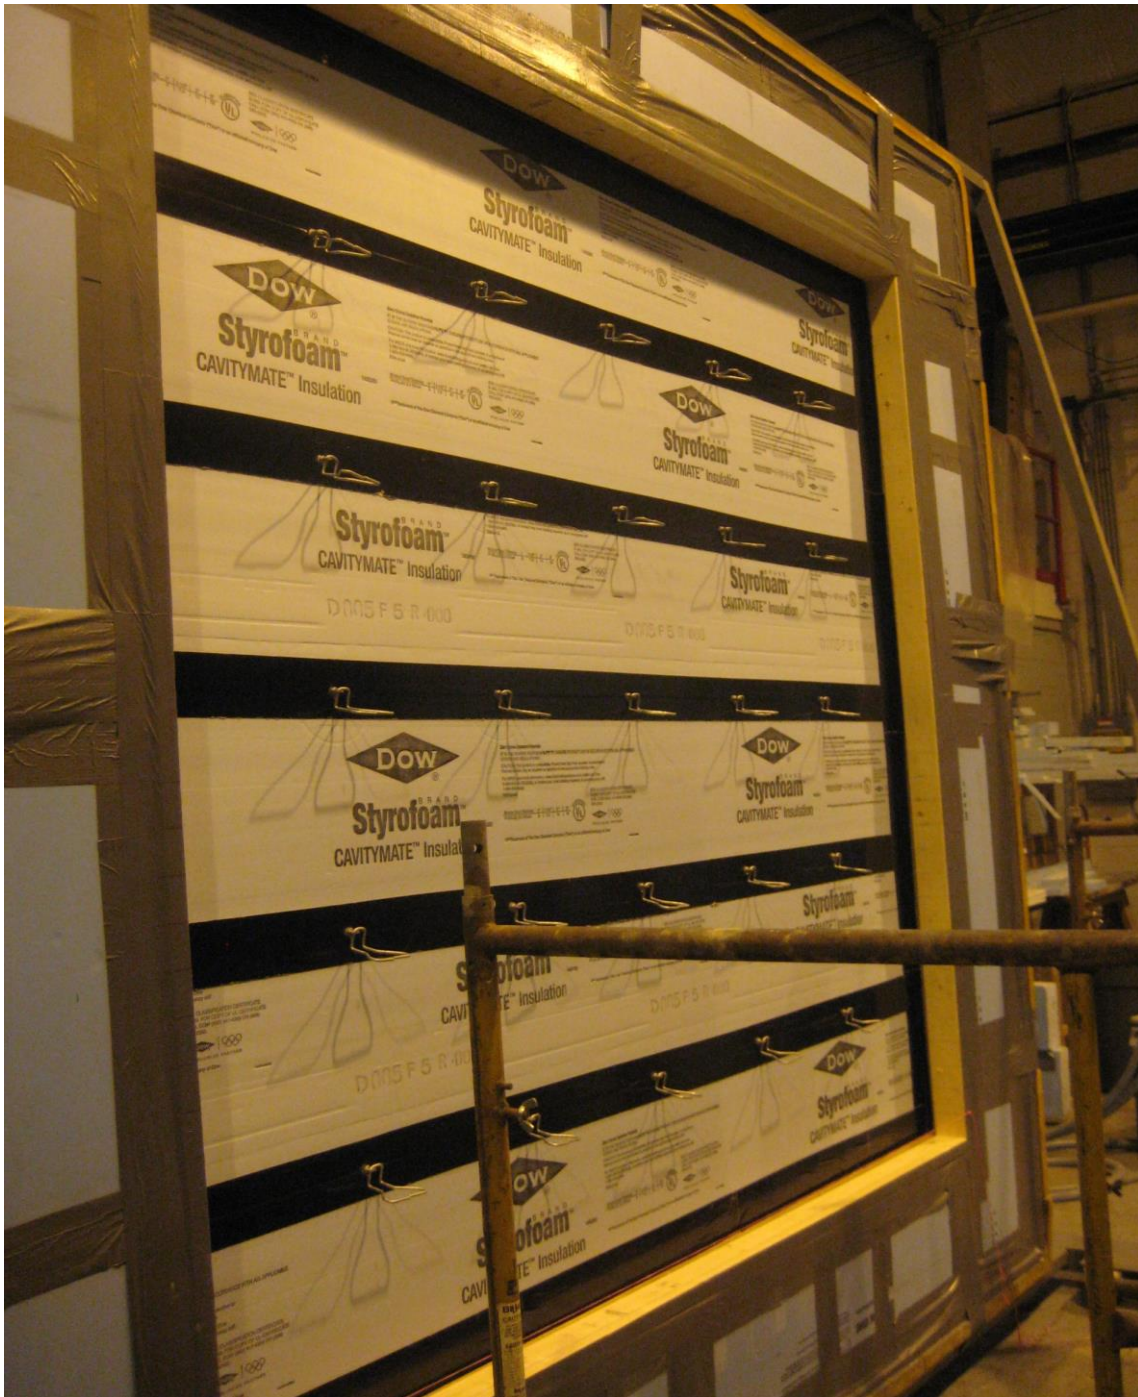
(Exterior of Base Wall, Sealed Foam & Brick Ties installed)

2" Ridgid Insulation Board - 2" DOW STYROFOAM™ Brand CAVITYMATE™ Insulation, installed horizontally, and the seams and edges were sealed with 4" DOW WEATHERMATE™ Straight Flashing

Wire-Bond Sure-Tie Fastener 2-1/2" Climaseal Coating barrels were screwed through the 2" ridgid insulation and 5/8" DensGlass, and into the steel studs every 16 inch on-center

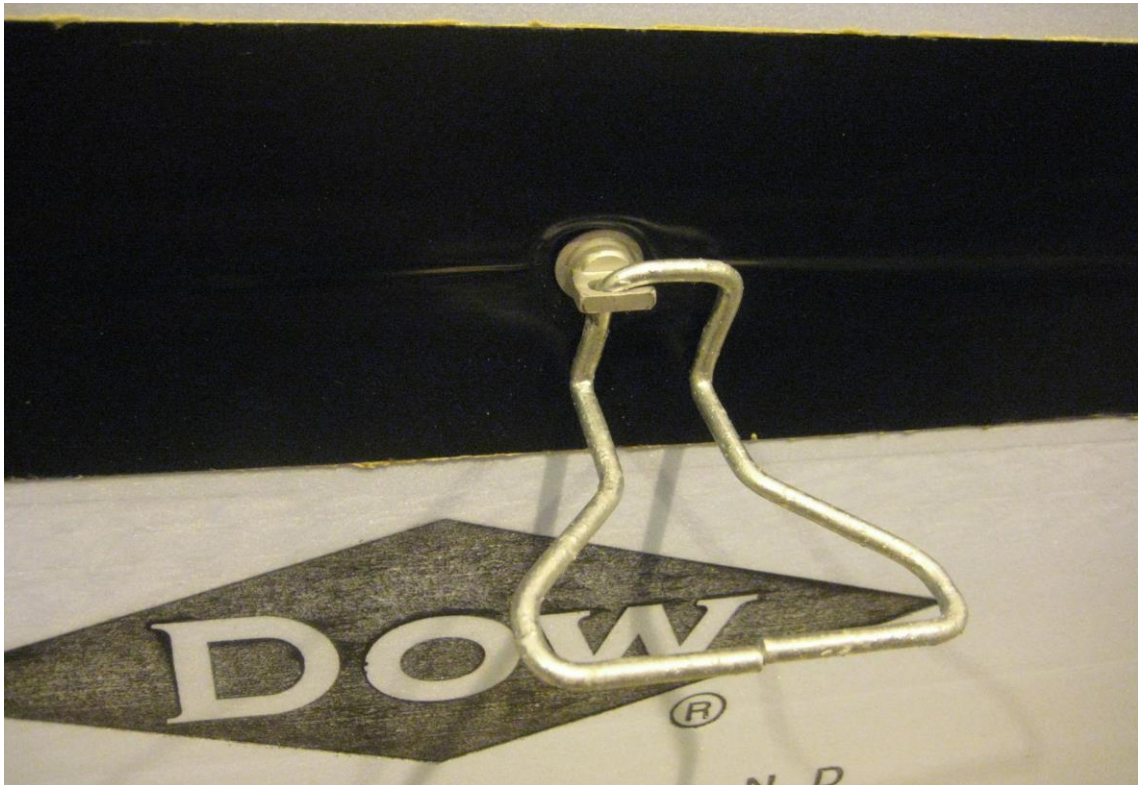
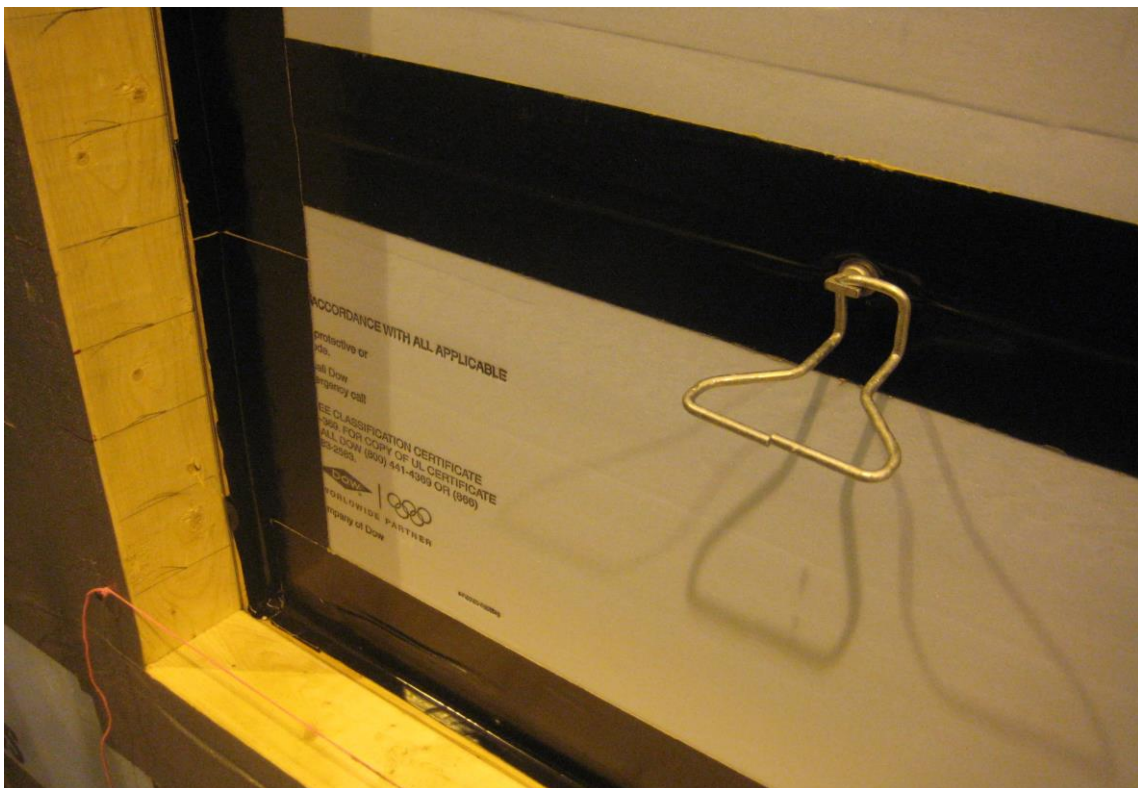
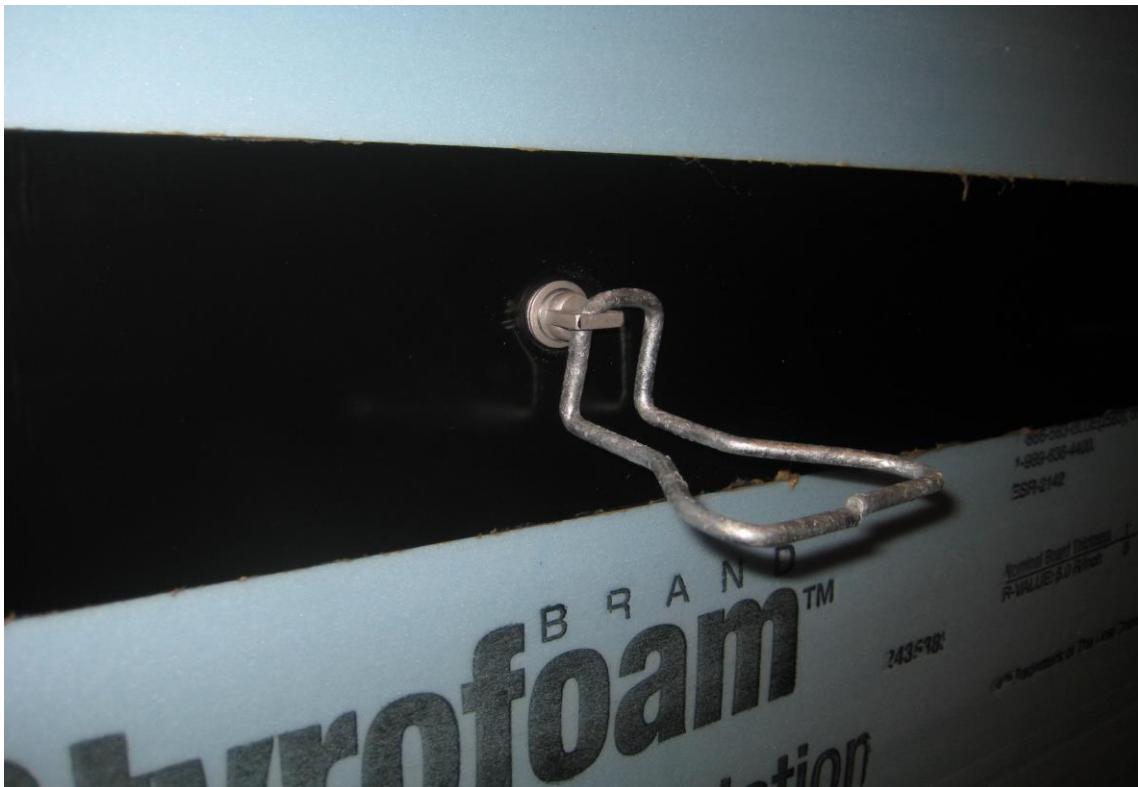
(Brick Tie installed)

Wire-Bond Sure-Tie Adjustable Triangle 3" Triangle with a 3/16" Dia. Wire HD GALV were connected to each Wire-Bond Sure-Tie Fastener 2-1/2" Climaseal Coating barrel

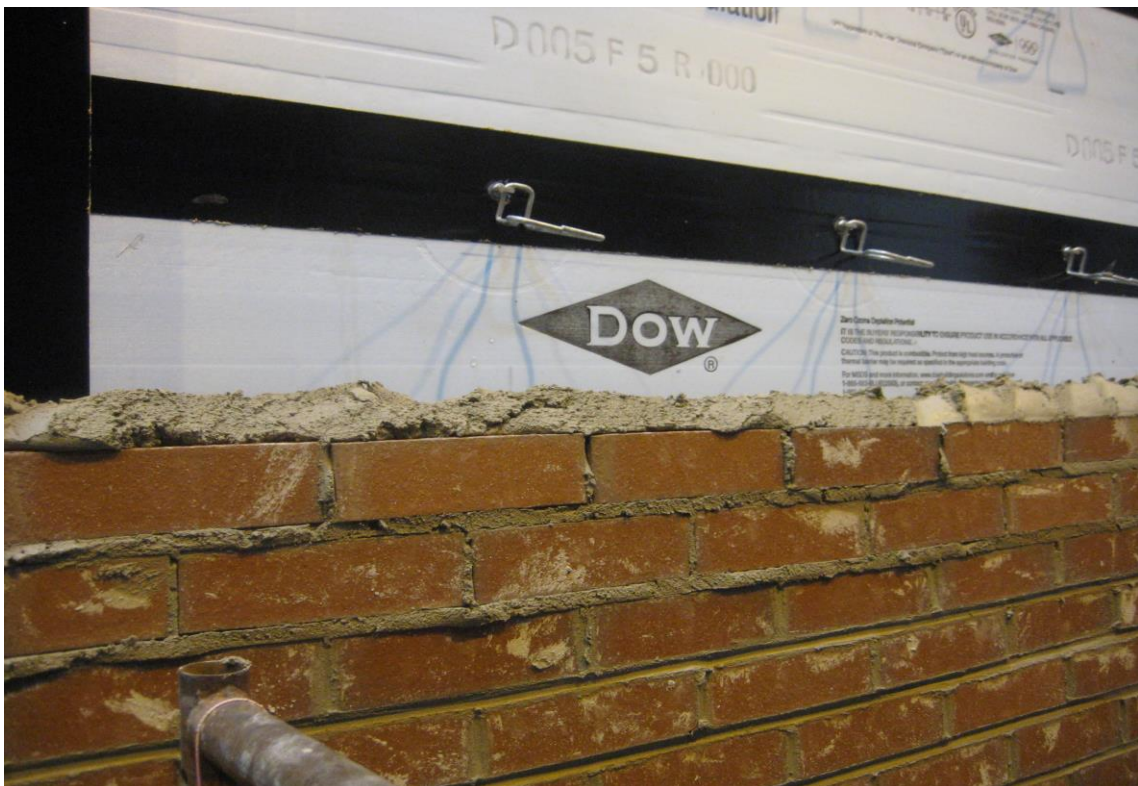
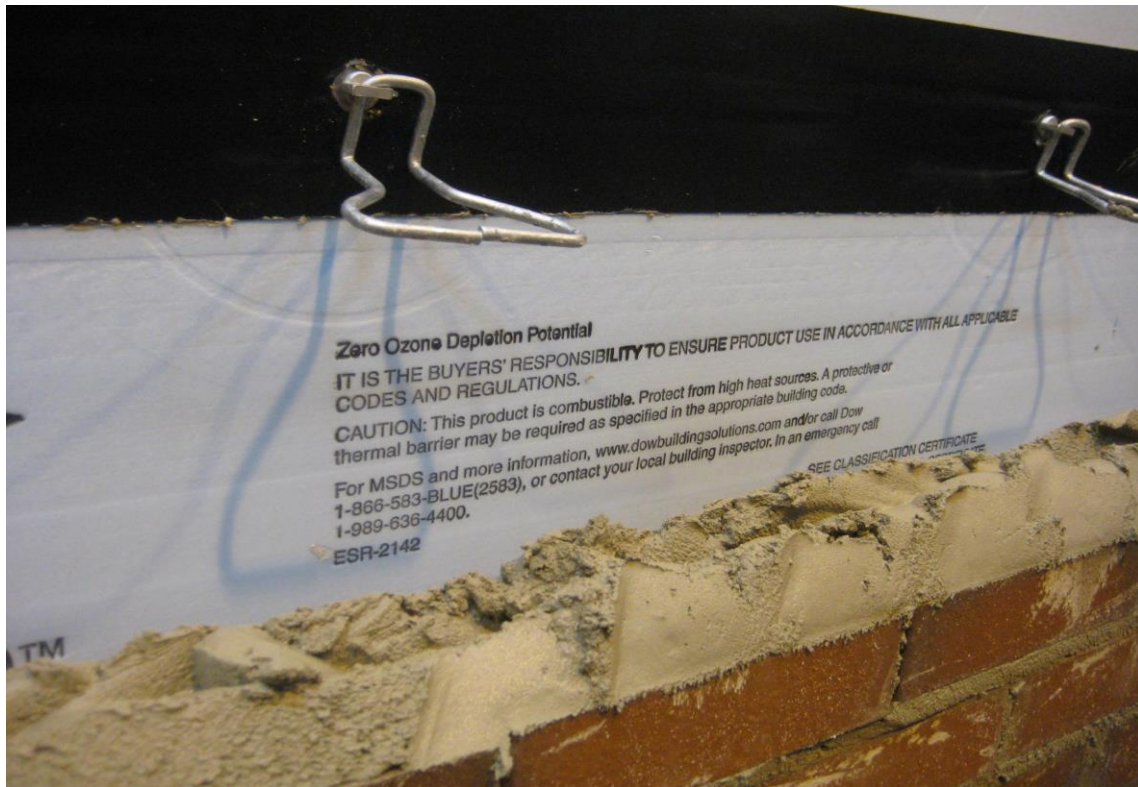
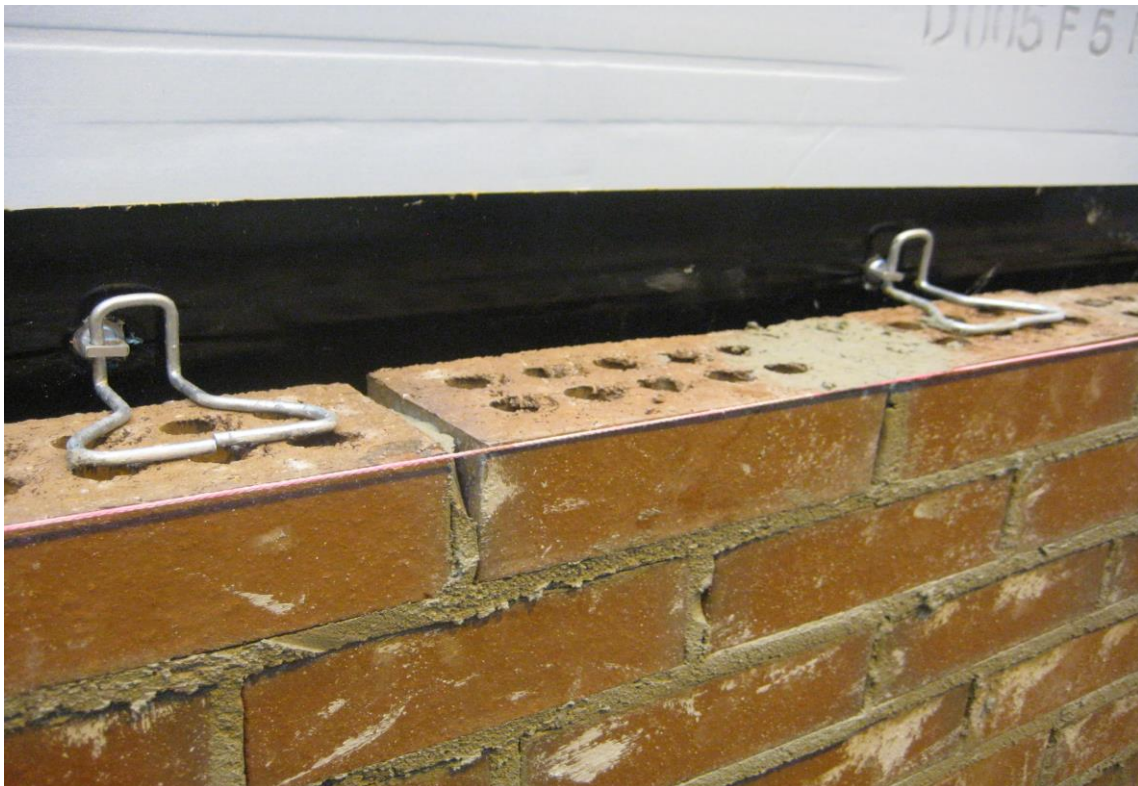
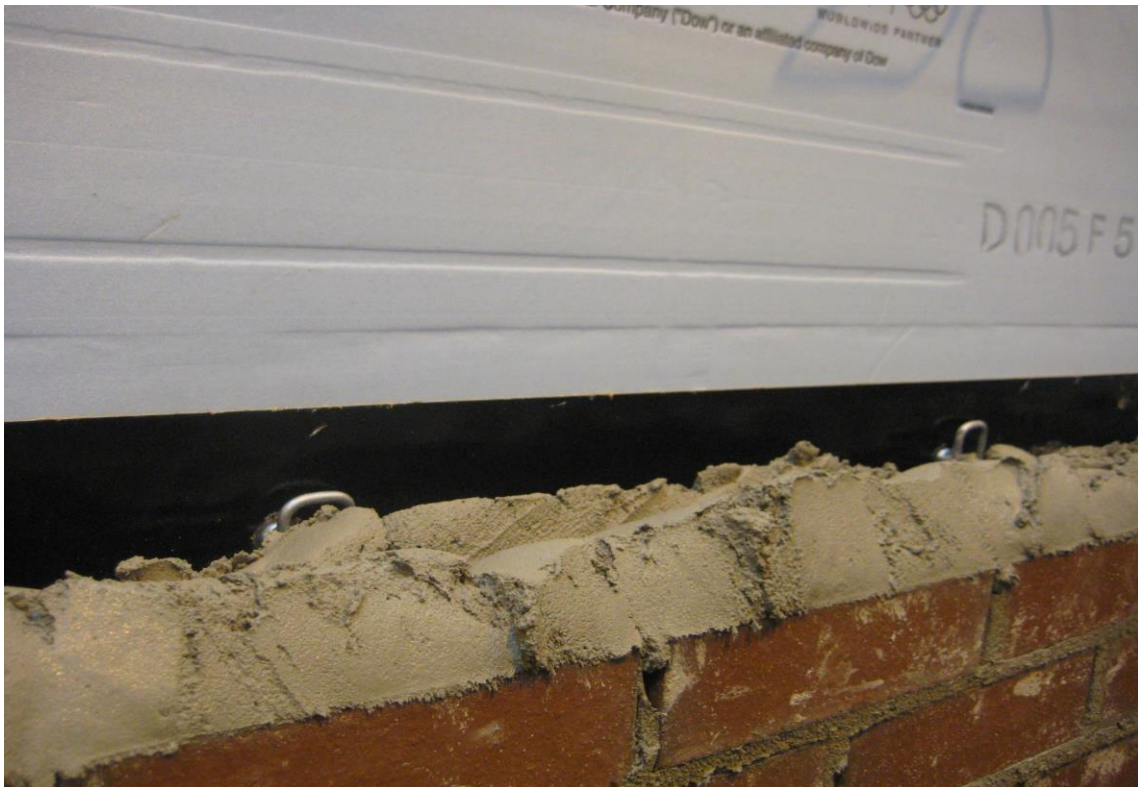
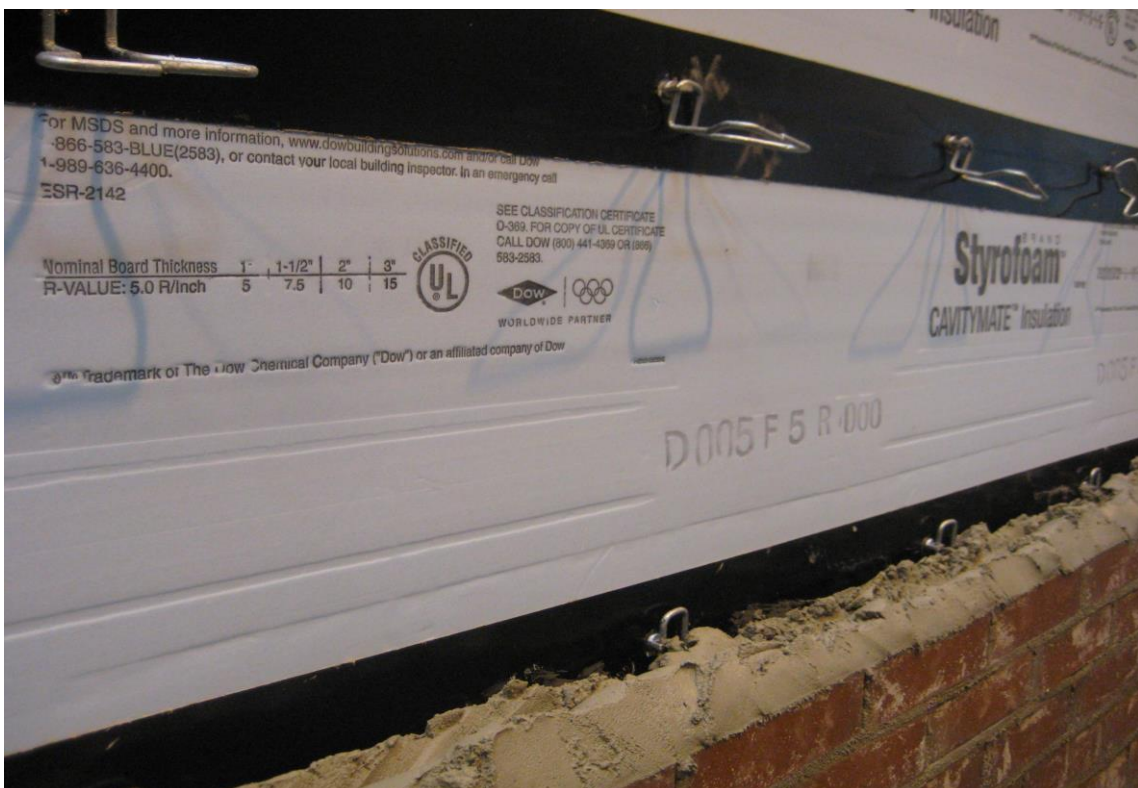
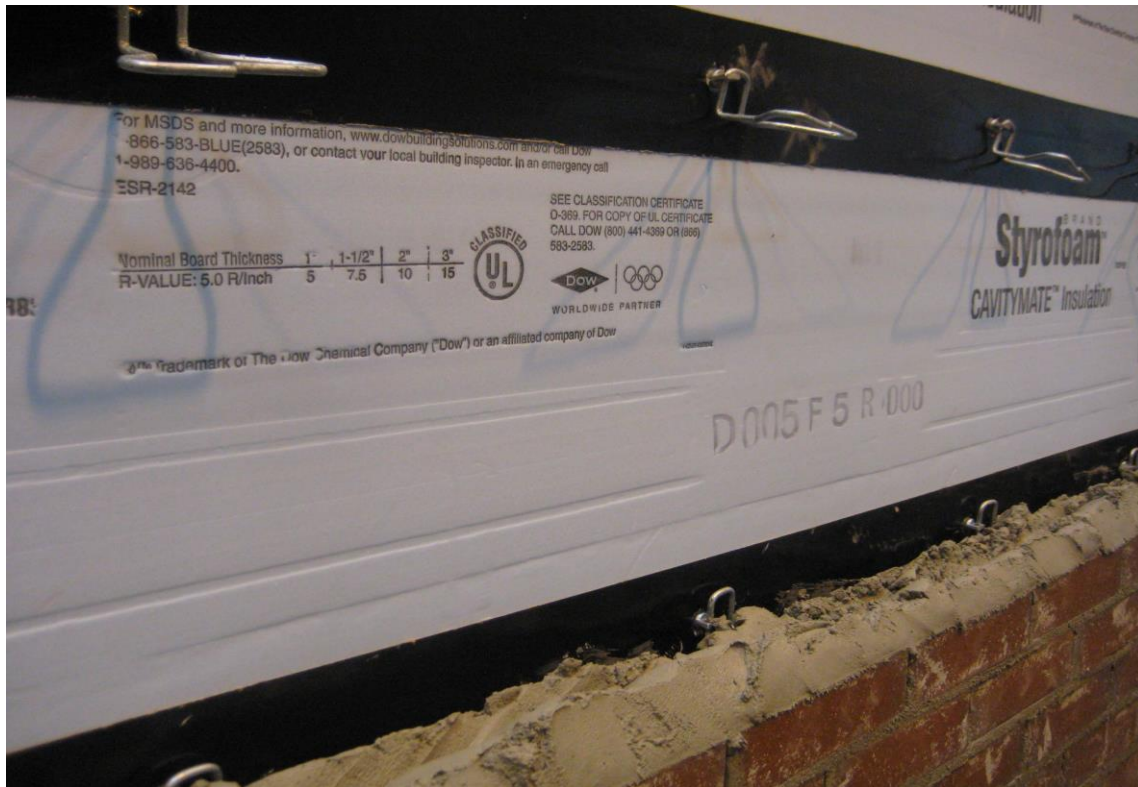
(Exterior of Base Wall, Bricks & Brick Ties being Installed)

Exterior Façade - Common red brick (7-3/4" x 2-1/4" x 3-1/2") were assembled with HI-STRENGTH Masonry Cement for Type S Mortar, with the Wire-Bond Sure-Tie Adjustable Triangle 3" Triangle with a 3/16" Dia. Wire HD GALV installed into the mortar joints

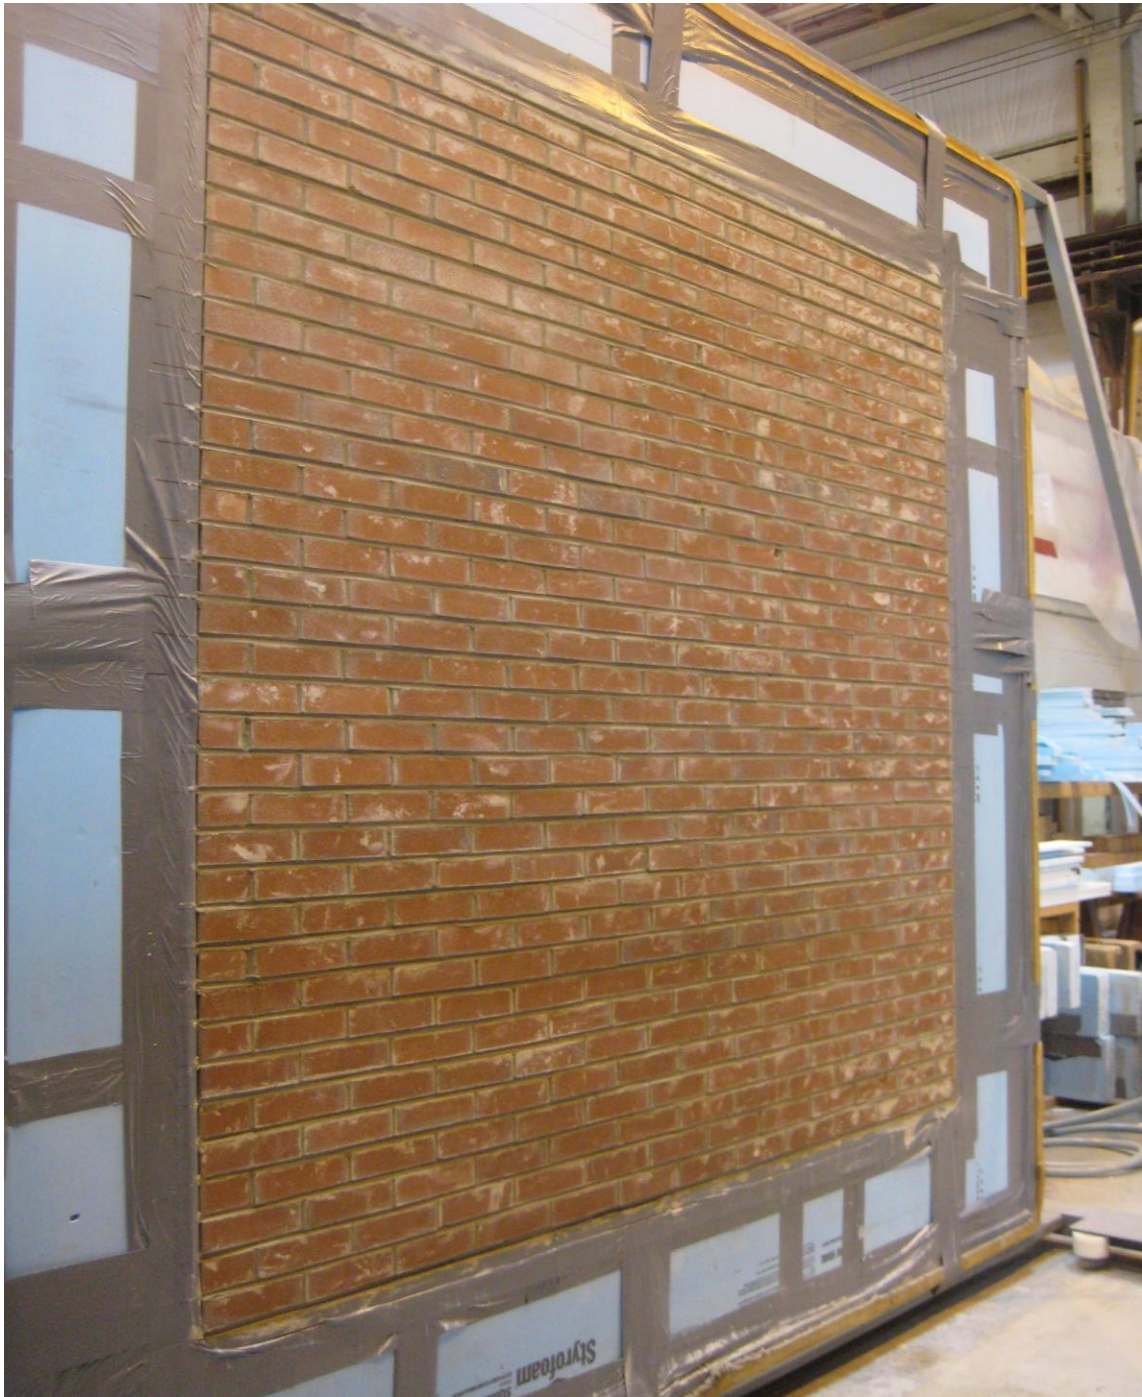
(Exterior Brick Wall Completed)

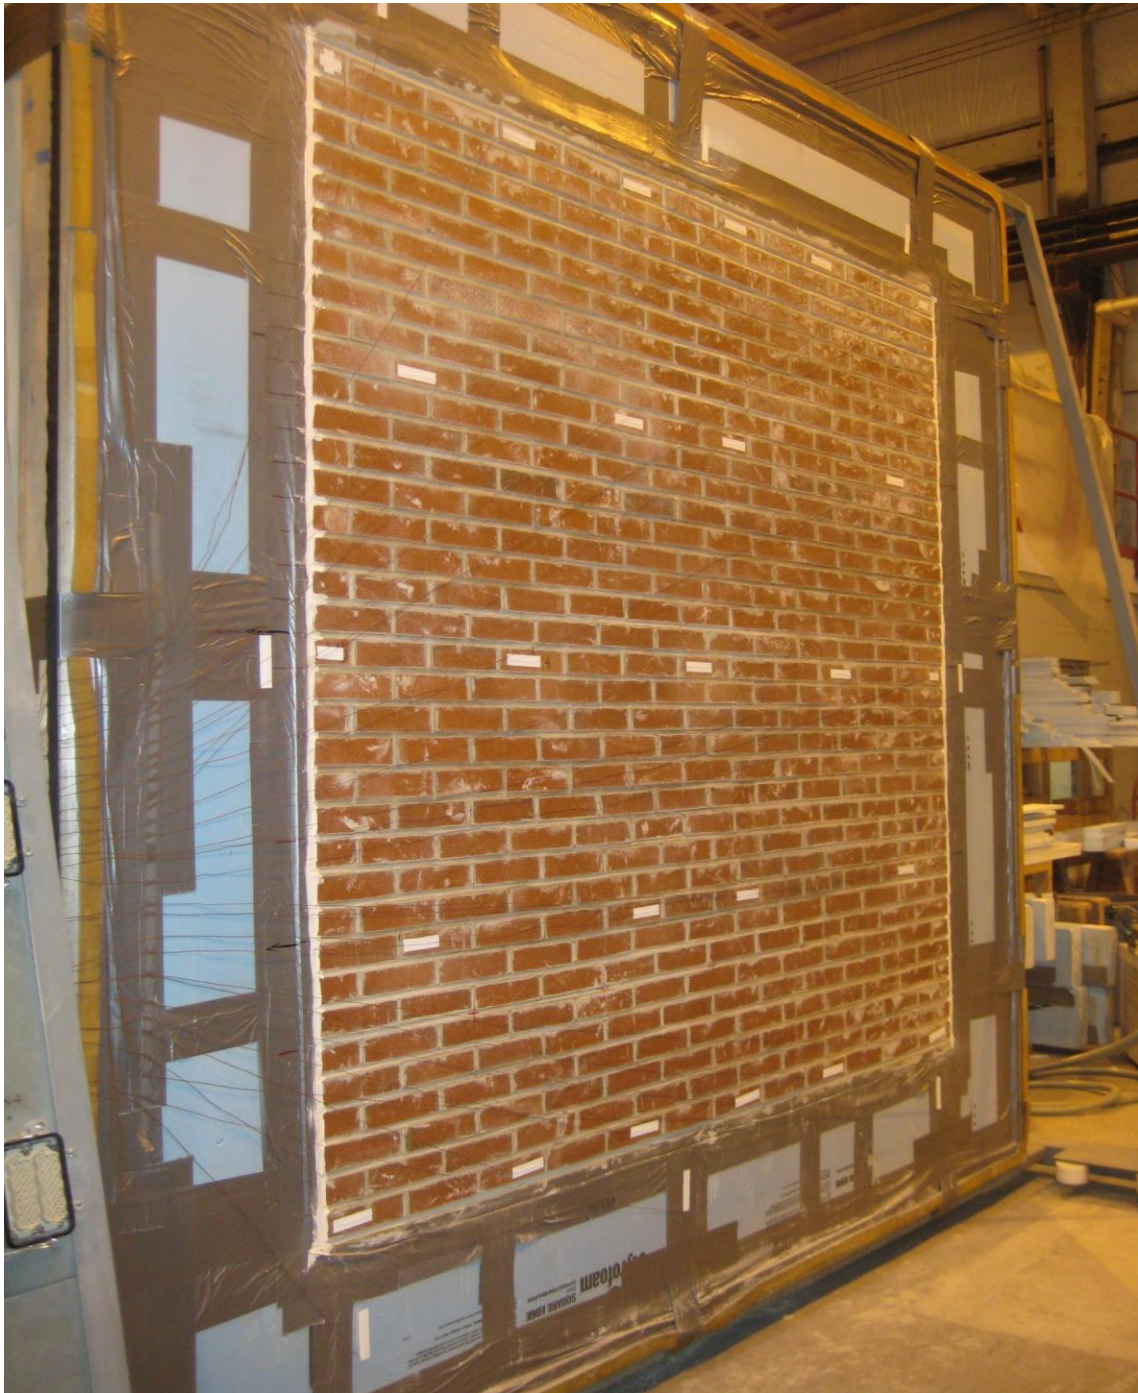
(Exterior Brick Wall Completed & Instrumented)

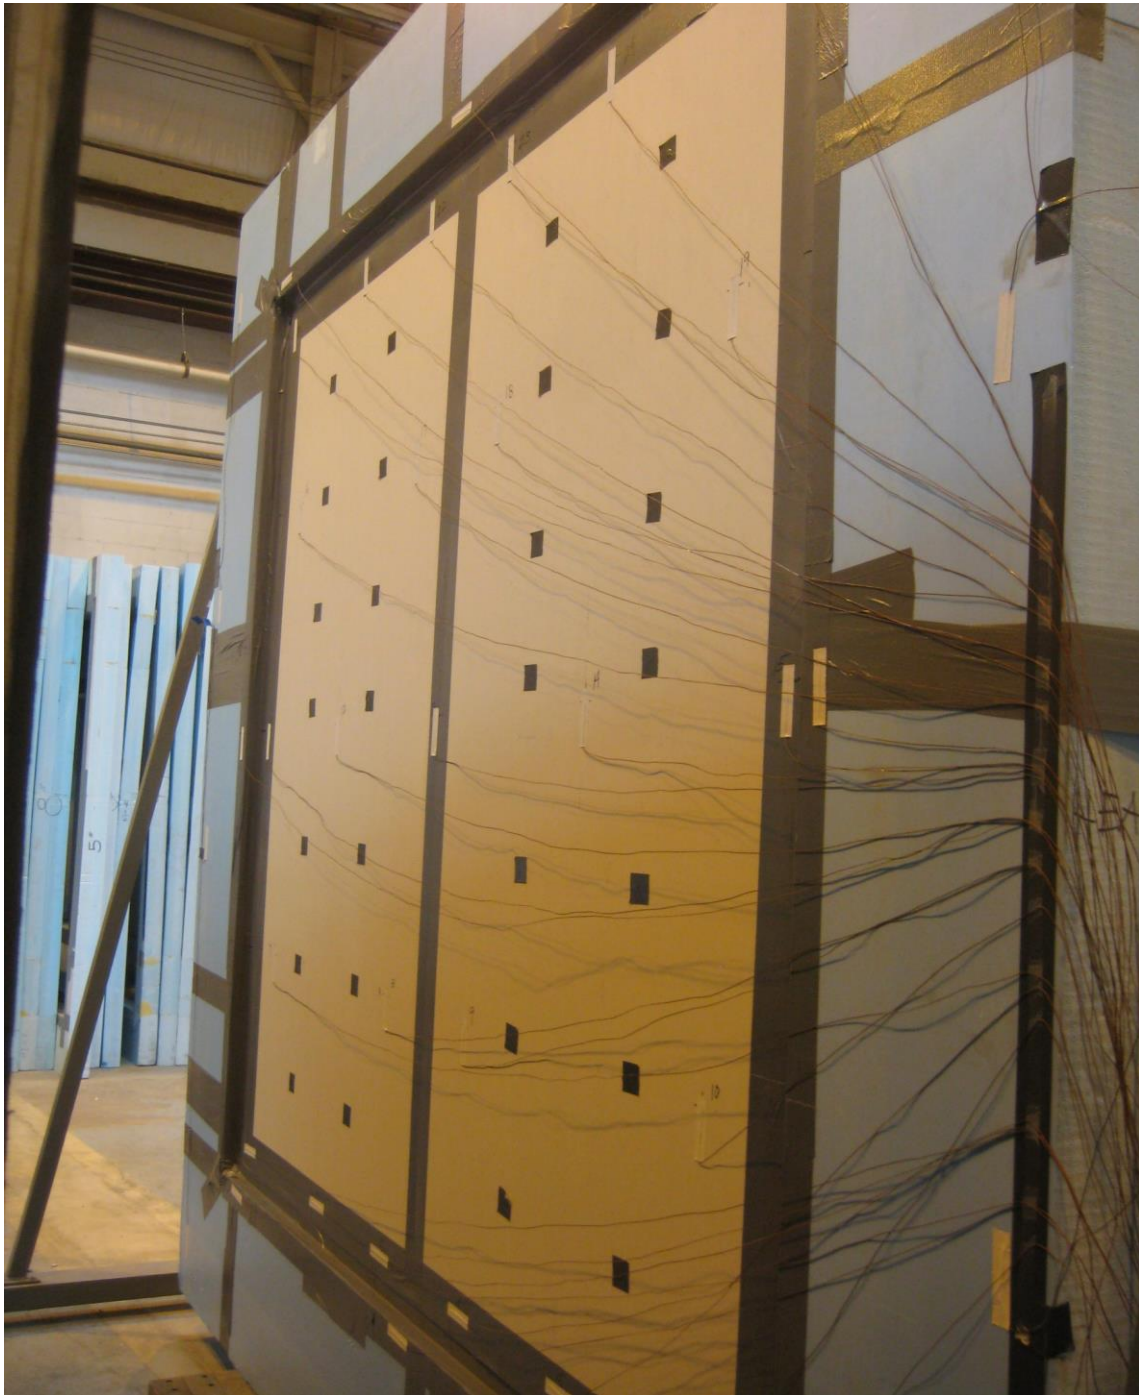
(Interior of Base Wall with Brick Ties Instrumented)

Test #1 was built with the Wire-Bond Sure-Tie Fastener 2-1/2" Climaseal Coating barrels and Wire-Bond Sure-Tie Adjustable Triangle 3" Triangle with a 3/16" Dia. Wire HD GALV, and for **Test #2** they were removed.

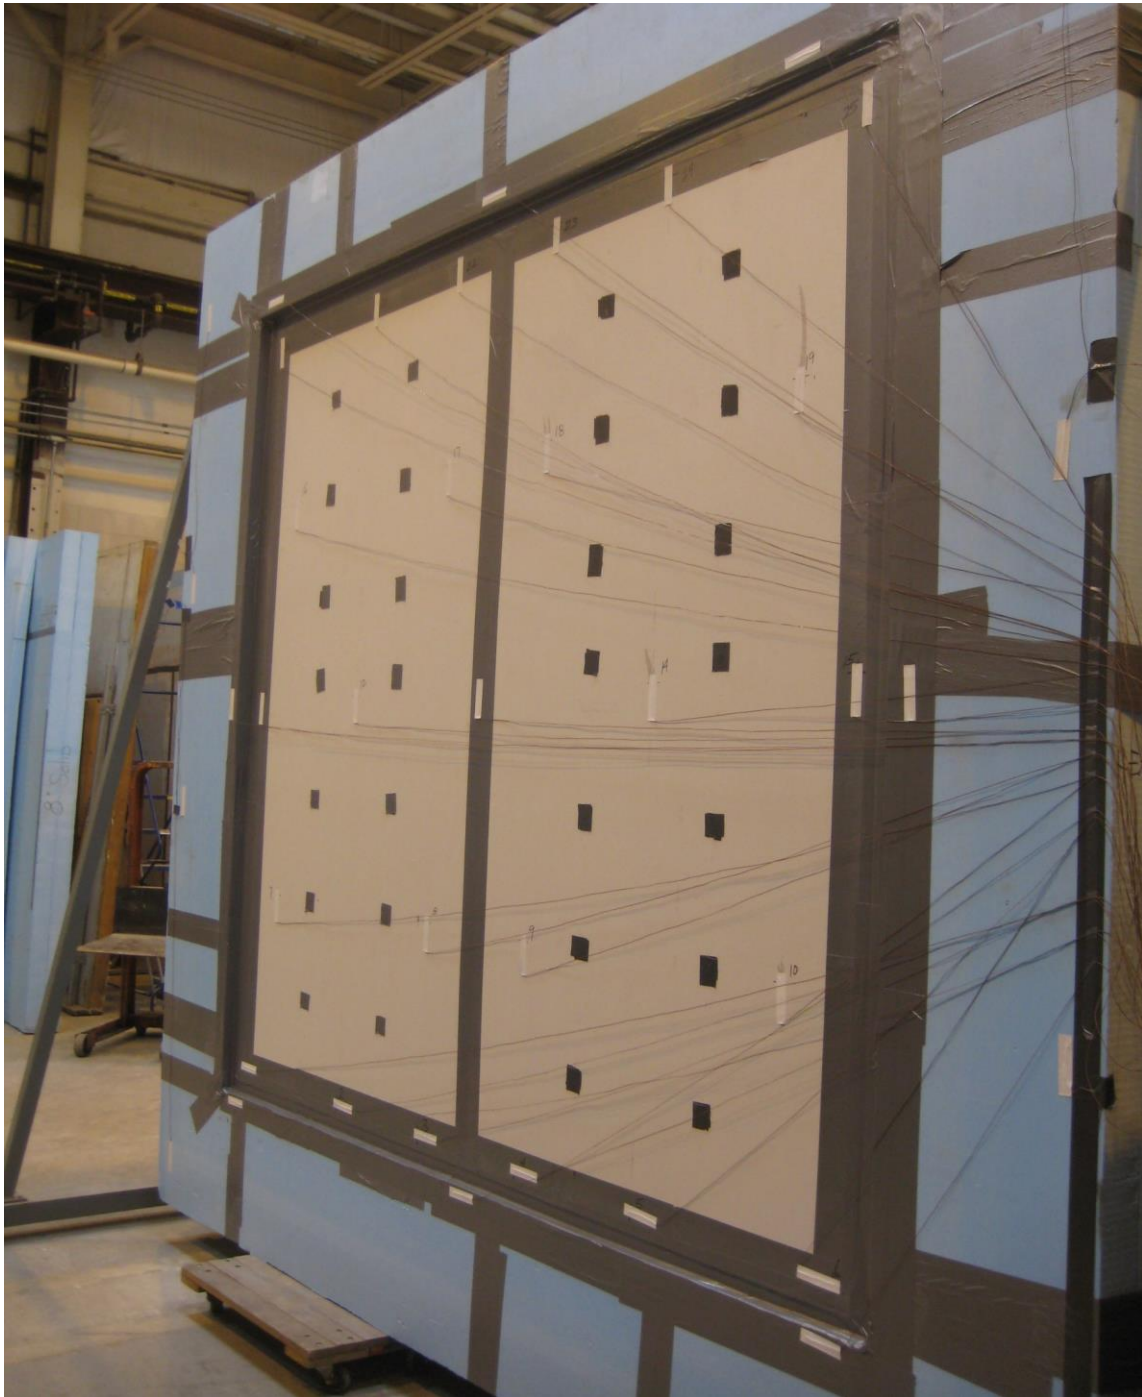
(Interior of Base Wall with-out Brick Ties Instrumented)
